**FIRE SAFETY FOLLOW UP INSPECTION**

<b>Factory Name</b>	Reza Fashion Ltd		<b>Accord ID</b>	9457
<b>Address</b>	Gorat, Baghbari, Ashulia, Savar			
<b>Inspection Date</b>	16/03/2014		<b>Report Received Date</b>	
<b>Date of 1st Follow-up</b>	20/October/14	<b>Date of 2nd Follow-up</b>	13/December/15	
<b>Date of 3rd Follow-up</b>	20/March/16	<b>Date of 4th Follow-up</b>	16/June/16	
<b>Date of 5th Follow-up</b>	05/September/16	<b>Date of 6th Follow-up</b>	27/November/16	
<b>Date of 7th Follow-up</b>	08/February/17	<b>Date of 8th Follow-up</b>	02/May/17	
<b>Date of 9th Follow-up</b>		<b>Date of 10th Follow-up</b>		
<b>Inspected by</b>	Nasif Javed Tofa

## Structural Safety Inspection

**ELECTRICAL SAFETY FOLLOW UP INSPECTION REPORT (8<sup>th</sup>)**

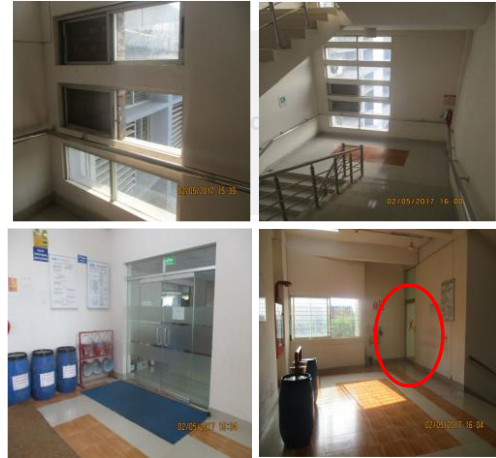
2	The exit stairs are not separated from work areas and other spaces on each floor by fire rated construction.	Provide minimum 1.5-hr fire rated doors and seal all unprotected openings to separate the exit stairs from work areas and other building spaces on all floor levels. Ensure that the fire doors are self-closing and positive latching and that they are provided with fire exit (panic) hardware where serving production floors. If fire doors are required to be held open for functional reasons, provide automatic closing devices tied to the fire alarm system.	Within 3 months	On 20/03/2016: Still work in progress. Several openings are unprotected inside the stairwells. Moreover stairwell windows are less than 10 ft. from factory windows in some cases. Factory has to ensure proper separation of stairwells. On 16/06/2016: Fire doors are missing at several locations of exit stairs e.g. office rooms & other occupancies, additional emergency exit stair. Factory needs to provide fire doors where applicable. To keep fire door open proper interfacing is required. Unprotected opening within 10 ft. from floor windows shall be sealed. On 27/11/2016: East stair is not separated from office and store (ground to top floor). All the installed fire door was found open manually. On 8-2-2017: Office spaces, spot removing rooms and other occupancies need separation. On 02/05/2017: Office area on each floor, maintenance room on various stair landing are not properly separated yet. Besides unseal penetrations were found on stair-2 and 4 which is required to be sealed. Installed fire doors were found kept open through some external sources.	30/04/2016	In Progress. Time Line: 31 Jan 2017	In Progress

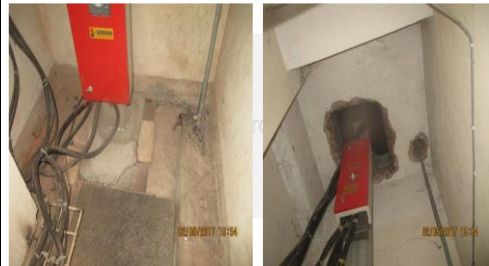
Item No	Accord Observation	Accord Recommendation	Timeline given by Accord	Comments after Physical Inspection	Supposed to complete(DD/MM/YYYY)	Final Action Plan (Factory)	Status on the date of Inspection	Pictorial Evidence
3	Unsealed penetrations and openings are located in the fire-rated floor/ceiling assemblies.	Provide a minimum 2-hr fire rated shaft to separate the utility risers from each floor level. Seal all penetrations and openings in floor/ceiling assemblies to maintain the fire separation.	Within 3 months	On 20/03/2016: In progress. Only at one floor penetration has been sealed. The rest are same as before. On 16/06/2016: In Progress. Penetrations shall be sealed to maintain proper fire rating. On 27/11/2016: Corrected in 5th follow up. On 8-2-2017: Corrected. On 02/05/2017: Corrected as per previous follow-up.	20/04/2016	Corrected	Corrected

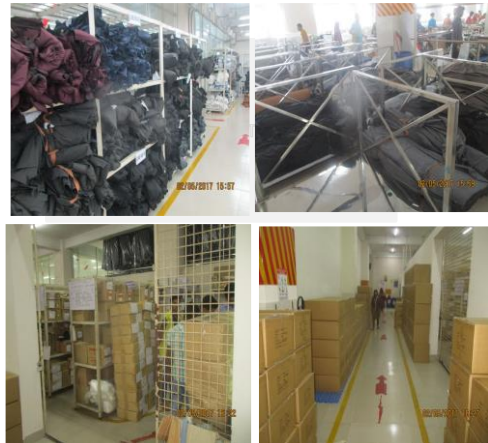
4	Areas used for combustible storage are not separated by fire rated construction. Location: Ground Floor	Provide dedicated storage rooms separated by minimum 1-hr fire-rated construction. Where separate storage rooms are not feasible, provide defined storage areas and limit the storage arrangement as follows: - Maximum height of 2.4m and maximum area of 23m2 - If sprinkler protected: maximum height of 3.66m and maximum area of 93m2 Separate areas of unenclosed combustible storage by a minimum clear distance of 3m.	Within 3 months	On 20/03/2016: Pile dimension requirements are not being maintained at 4th floor (South-west finished cartons storage space, east side fabric roles storage areas). At ground floor fabric go down is not protected from the adjacent finishing section. On 16/06/2016: In progress. Proper guideline shall be followed. On 5th September 2016 As action plan of the factory: In Progress. It has found same as it was before follow-up inspection. On 27/11/2016: Central store at ground floor is not separated yet. Pile dimension requirements are not being maintained at 4th floor. On 8-2-2017: Central store separation work is in progress. Area storages need to be defined at 4th floor. On 02/05/2017: <b>Dedicated store:</b> Store room on ground floor is not properly separated yet from the production area. <b>In-process store:</b> Temporary storages were found on various floors without any proper store arrangements.	15/04/2016	In Progress. Time Line: 31 Jan 2017	In Progress

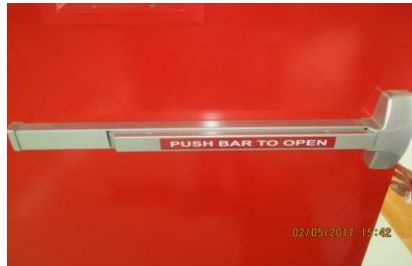
5	Egress doors / gates with locking features are provided at building exits, exit stairs, along egress routes, and exit discharge. Type/location: Folding steel gate located on all floors.	Remove locking features from all egress doors / gates. If locks are required for security reasons, utilize special door locking features complying with NFPA 101.	Immediate	On 20/03/2016: Corrected. Replaced/Removed. On 16/06/2016: Corrected. On 5th September 2016 As action plan of the factory: Corrected. On 27/11/2016: Corrected in 3rd follow up. On 8-2-2017: Corrected as per previous follow-up. On 02/05/2017: Corrected.	16/12/2015	Corrected	Corrected

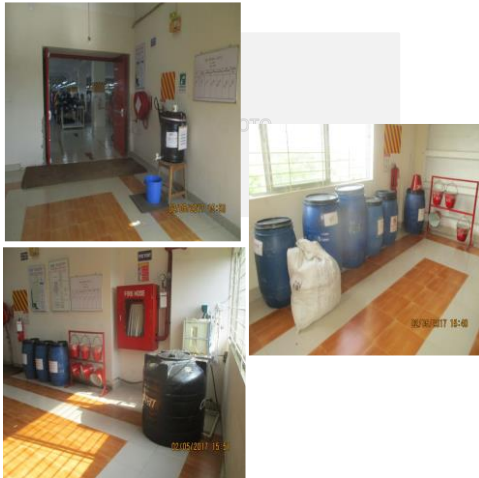
Item No	Accord Observation	Accord Recommendation	Timeline given by Accord	Comments after Physical Inspection	Supposed to complete(DD/MM/YYYY)	Final Action Plan (Factory)	Status on the date of Inspection	Pictorial Evidence
6	Storage was located in the exit stair. Locations: Top of all stairwells. Ground floor west side stairwell. 5th floor where construction is going on.	Remove all storage from exit stairs and egress paths.	Immediate	On 20/03/2016: At 4th floor west stair spot removing room was found. At ground floor compressor set up was found inside the staircase. On 16/06/2016: Spot removing room has been removed but ground floor compressor room was found in same condition. On 5th September 2016 As action plan of the factory: In Progress. It has found same as it was before follow-up inspection. On 27/11/2016: Compressor room has been separated by brick wall but still storage with non separated office was found in the west exit stair at each floor level. On 8-2-2017: A small set up of tables & chairs is in use at several floors of stair 3. On 02/05/2017: Drinking water facilities, combustible stores, boiler processing water tank etc. were found on the stair landing. Besides maintenance room was found on various stair landing.	20/04/2016	In Progress. Time Line: 31 Jan 2017	In Progress

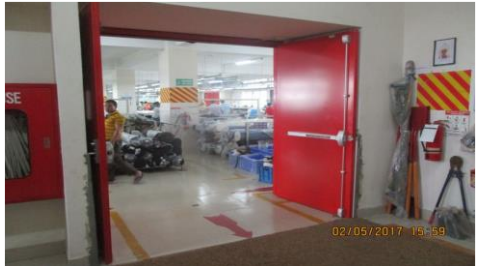
7	Exit stair door does not swing in the direction of egress travel. Location: East side stairwell 5th floor.	Modify the egress door to swing in the direction of egress travel.	Within 3 months	On 20/03/2016: Corrected. On 16/06/2016: Corrected. On 5th September 2016 As action plan of the factory: Corrected. On 27/11/2016: Corrected in 2nd follow up. On 8-2-2017: Corrected as per previous follow-up. On 02/05/2017: Corrected.	20/11/2015	Corrected	Corrected

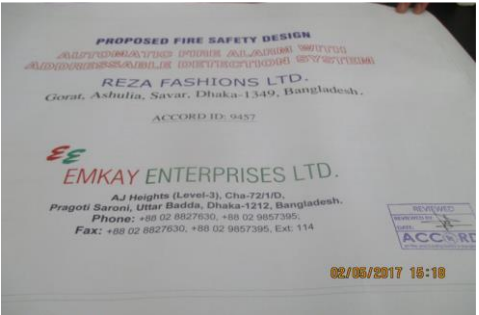
8	The fire alarm system is antiquated, not a listed system, and does not provide alarm and notification features consistent with acceptable standards.	Replace the fire alarm system with a new, listed addressable fire alarm system in accordance with NFPA 72.	Design within 4 months, install within 9 months.	On 20/03/2016: Design reviewed by Accord. Installation has not been started yet. On 16/06/2016: In Progress. Factory has told that L/C for fire alarm system shall be opened soon. On 5th September 2016 As action plan of the factory: In Progress. During visual inspection the installed conventional fire alarm system is okay but it is not capable to support different interfacing module required for exhaust fans, fire doors, fire pump, lift etc. However L.C is done for listed fire alarm system and as confirmed by the factory that the alarm equipment is already shipped and waiting to be delivered. On 27/11/2016: Installation has not started yet even imported equipment is not delivered yet. On 8-2-2017: Installation is in progress. On 02/05/2017: Installation work is in progress. Reviewed design was available.	20/05/2016	In progress. Equipment is in House. Time Line: 31 Jan 2017	In Progress

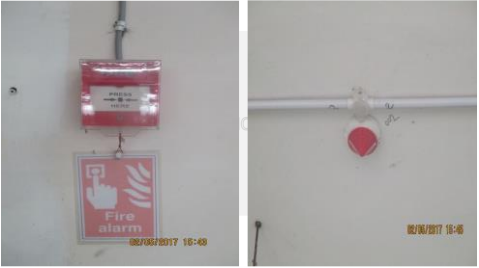
10	Activation of the fire alarm system by a manual fire alarm station provides automatic occupant notification only on the floor of alarm and not throughout the building.	Configure the fire alarm system to initiate automatic occupant notification on all floor levels to facilitate whole building evacuation upon any manual fire alarm station activation.	Within 1 months	On 20/03/2016: It is an integrated part of fire alarm & detection system. On 16/06/2016: It is integrated part of fire alarm system. On 5th September 2016 As action plan of the factory: Corrected. On 27/11/2016: It is integrated part of fire alarm system. On 8-2-2017: Integrated part of fire detection & alarm system. On 02/05/2017: It is an integrated part of fire alarm & detection system.	20/05/2016	In progress. Equipment is in House. Time Line:31 Jan 2017	In Progress

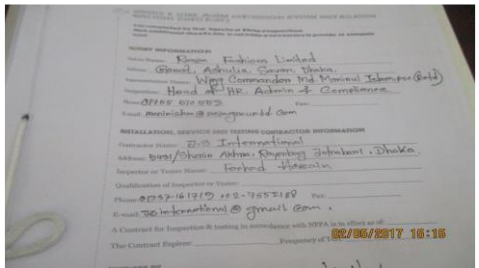
11	Inspection, testing, and maintenance records for the fire alarm system were not available.	Inspect, test and maintain the fire alarm system, and keep written records on-site, in accordance with NFPA 72.	Within 3 months	On 20/03/2016: No action has been taken yet. On 16/06/2016: No action has been taken yet. On 5th September 2016 As action plan of the factory: Corrected. (Inspection, testing, and maintenance records for the existing fire alarm system in accordance with the ACCORD standard). On 27/11/2016: Corrected in 5th follow up. On 8-2-2017: Corrected as per previous follow-up. On 02/05/2017: Corrected.	20/05/2016	In Progress. Addressable fire alarm system drawing has been reviewed by ACCORD and Equipment LC would be opened within July, 2016.	Corrected

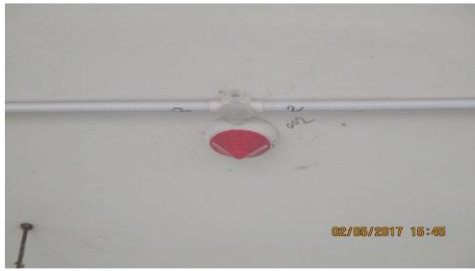
Item No	Accord Observation	Accord Recommendation	Timeline given by Accord	Comments after Physical Inspection	Supposed to complete(DD/MM/YYYY)	Final Action Plan (Factory)	Status on the date of Inspection	Pictorial Evidence
12	The building is equipped with single-station smoke alarms. Smoke alarm activation sounds only a local alarm and does not provide automatic fire alarm notification of occupants.	Replace the single-station smoke alarms with automatic smoke detectors tied into the fire alarm system. Configure the fire alarm system to initiate occupant notification upon activation of any two smoke detectors in addition to the manual fire alarm stations.	Within 6 months	On 20/03/2016: It is an integrated part of fire alarm & detection system. On 16/06/2016: It is integrated part of fire alarm system. On 5th September 2016 As action plan of the factory: Corrected.  On 27/11/2016: It is integrated part of fire alarm system. On 8-2-2017: Integrated part of addressable detection system. On 02/05/2017: It is an integrated part of fire alarm & detection system.	20/05/2016	In progress. Equipment is in House. Time Line:31 Jan 2017	In Progress

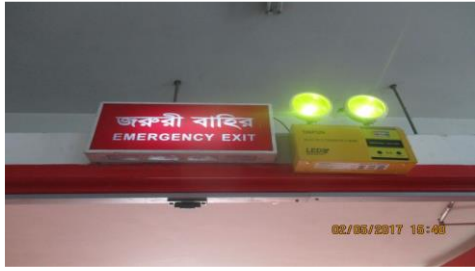
13	Emergency lighting did not function in test mode (burned out, broken, etc.). Locations: All Locations were not working properly	Regularly test the emergency lighting system on each floor and replace/repair lights as needed.	Within 1 month	On 20/03/2016: Corrected. On 16/06/2016: Corrected. On 27/11/2016: Corrected in 1st follow up. On 8-2-2017: Corrected as per previous follow-up. On 02/05/2017: Corrected.	20/11/2015	Already fixed all burnt and broken lights.	Corrected

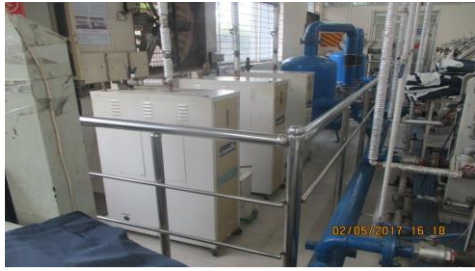
14	New Finding in 1st follow-up: The boiler room is not separated by fire-rated construction.	Separate the boiler room by a minimum 1-hr fire-rated construction. Seal and/or protected all openings to maintain the required fire separations.	Within 3 months	On 20/03/2016: Corrected at 2nd follow-up. On 16/06/2016: Corrected. On 5th September 2016 As action plan of the factory: Corrected.  On 27/11/2016: Corrected in 2nd follow up. Note: Electric mini boiler shall be separated by 5 inch brick wall and heavy metal/steel door shall be provided. On 8-2-2017: Corrected as per previous follow-up. On 02/05/2017: Corrected as per previous follow-up. However it is required to provide fire rated wall of 5 inch thickness and heavy metal/steel door to access for proper fire separation.	20/11/2015	Corrected	Corrected

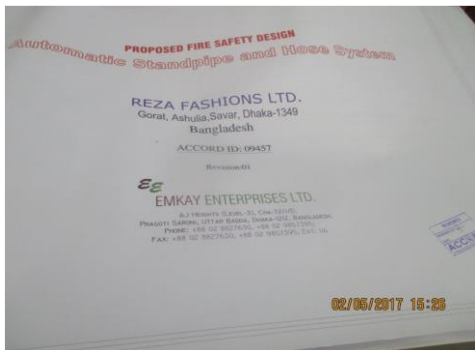
15	New Finding in 3rd follow-up: Standpipe system is required for the building, which has an occupiable floor 10 m (33 ft) or more above grade. Note: Reviewed design from Accord was found as per design.	Complete the installation of the standpipe system as per design reviewed including the required interfacing of fire pump controls with approved fire alarm system.	Within 3 months	On 16/06/2016: In progress. Reviewed drawing was found during inspection. Installation work is going on. On 5th September 2016 As action plan of the factory: In Progress. It has found same as it was before follow-up inspection. On 27/11/2016: Installation was almost completed. Fire pump controls shall be interfaced with FACP if applicable. All valves controlling connections to water supply and fire pumps shall be listed or approved as per NFPA 14, section 4.5.1. Commissioning of the system in-front of contractor/ 3rd party will be done by Accord. On 8-2-2017: Ensure the installation has been done as per design reviewed. Factory has to notify Accord for witnessing the final acceptance testing. On 02/05/2017: Reviewed design was available. Installation work is almost completed. Interfacing is still pending.	20/06/2016	In progress. Equipment is in House. Time Line:31 Jan 2017	In Progress

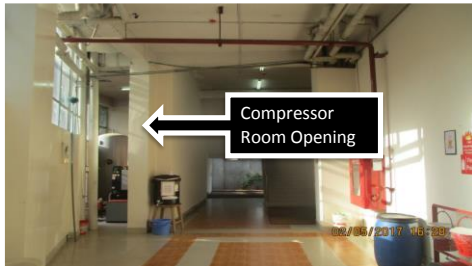
Item No	Accord Observation	Accord Recommendation	Timeline given by Accord	Comments after Physical Inspection	Supposed to complete(DD/MM/YYYY)	Final Action Plan (Factory)	Status on the date of Inspection	Pictorial Evidence
16	New Finding in 3rd follow-up: The compressor set located in the exit stair is not separated by fire rated construction. Location: Ground floor (Inside west stair)	Remove the compressor from exit stair or separate the compressor room by a minimum 2hr fire rated construction. Seal and/or protected all openings to maintain the required fire separations.	Within 2 months	On 16/06/2016: No action has been taken yet. On 5th September 2016 As action plan of the factory: In Progress. It has found same as it was before follow-up inspection. On 27/11/2016: Corrected. Separated by brick wall. On 8-2-2017: Corrected as per previous follow-up. On 02/05/2017: Corrected as per previous follow-up. However it is required to seal the opening area along the discharge path.	20/05/2016	In Progress. Final Time Line: 20 Nov 2016.	Corrected

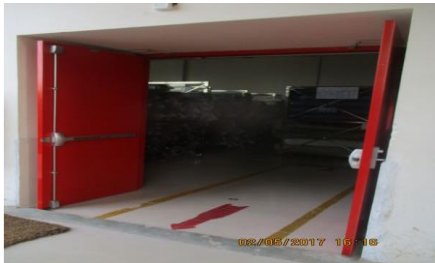
17	New Finding (4th Follow Up): Rooms used for storage of combustible materials are not separated from the surrounding occupancy/areas (Ground floor-Central store room).	Rooms used for storage of combustible materials shall be separated from the surrounding occupancy with a minimum 1 hour construction.	Within 1 month	On 5th September 2016 As action plan of the factory: Corrected. Factory has installed the listed fire rated door. On 27/11/2016: Corrected in 5th follow up! This issue is now addressed by the issue number 4. On 02/05/2017: Corrected as per previous follow-up.	16/07/2016	In Progress.	Corrected

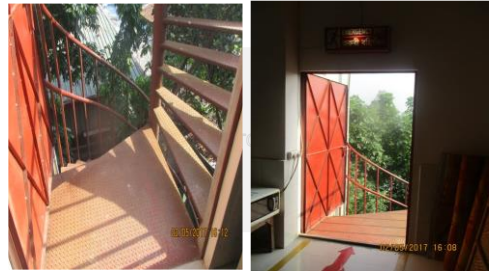
18	New Finding: The exterior exit stairs has unprotected openings to the building interiors.	Exterior exit stairs shall be separated from the building with a rating requirement of 2 hr fire rating for 4 or more stories. The rating of the exterior wall shall extend 3.05 m (10 ft) beyond the ends of the stair structure.	Within 1 month	On 27-11-2016: New Finding. On 8-2-2017: Work in progress. On 02/05/2017: In progress.	27/12/2016	In Progress. Time Line: 31 Jan 2017	In Progress

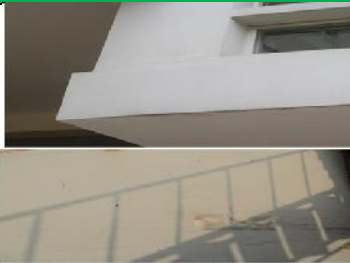
Item No	Accord Observation	Accord Recommendation	Accord Timeline	Final Action Plan	Final Timeline( DD/MM/YYYY)	Comments after Physical Inspection	Progress Status	Pictorial Evidence
1	Cracking of non-structural brick wall infill	Engineer to regularly monitor cracks and, in case the cracks increase, review structural behaviour.	Within 6 months	Corrected	12/06/2015	<p><b>On 20/10/2014:</b>The factory reviewed and repairing the crack by engineer inspection and instruction but not taken any written document's. On verification period we found more wall crack in 5th to 3rd floor in stair area -2,3&amp;4 and storing wastage materials in stair room.</p> <p><b>On 25/4/2017:</b> The factory management has to take written documents from the consultants regarding the cracks. They have to monitor the cracks properly.</p>	In Progress

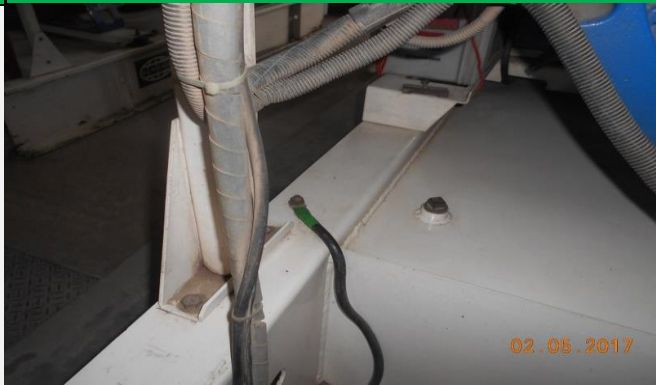
Item No	Accord Inspection Observation	Accord Action Plan (Recommendation)	Accord Time line (given in report)	Comments from Accord (After Physical Inspection)	Final Timeline (Approved timeline)	Final Action Plan (Factory)	Progress Status (On the date of inspection)	Pictorial Evidence
56	New Finding: Inadequate sized earth cable connected to generator & transformer frame.	Two separate earth connection & one separate and distinct Neutral connection must be provided over Transformer & generator. Generator & transformer body must have earth connection with half of phase conductor/follow manufacturer/suppliers recommendation.	1 Month	<b>On 02/05/2017:</b> Corrected.	25/03/2017		Corrected

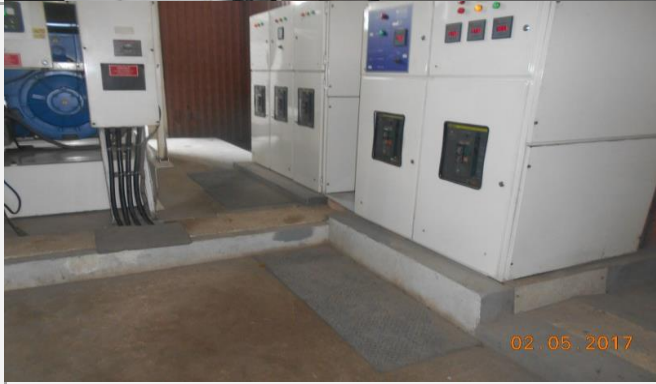
57	New Finding: Panel/Distribution boxes are inaccessible or cannot be opened to perform any maintenance work.  Panel/distribution board is not firmly fixed with the foundation.	Each electrical distribution board/panel must be easily accessible. In case of height its top shall not be higher than 2m from base; and door opening shall be at least 90 degree.  panel base must be securely fixed to the foundation. With appropriate fastening devices.	1 Month	<b>On 02/05/2017:</b> Not corrected. Panels are not fixed with base	25/03/2017		In Progress

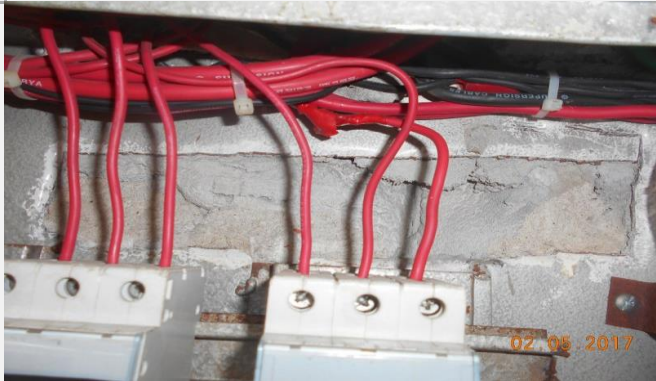
58	New Finding: Phase barrier/separator s are missing in MCCBs  Cables in service are joined (splicing) between terminations.	Phases must be separated by insulator (a rubber type no-flammable materials shall be used for it)  Splicing in the power cables shall be avoided; in unavoidable cases splicing, must be made following proper guidance.	1 Month	<b>On 02/05/2017:</b> Not corrected. Splicing joint is observed during inspection.	25/03/2017		In Progress
